ON-SITE SCHOOL BUS INVESTIGATION

CASE NO. - 95-22
FLEET - CORPORATE SCHOOL BUS
LOCATION -
ACCIDENT DATE - 1995

This report concerns a motor vehicle incident involving a 1981 Ford B700, Type C, 64-Passenger, Conventional Body (body by _____ School Bus and a pedestrian (prior bus occupant) occurring in _____ 1995 at _____ in a county on a State road. This incident is of special interest because the school bus's convex cross view mirrors were improperly positioned and/or of insufficient size to adequately detect the presence of a child who, after departing the bus, was subsequently run over and fatally injured.

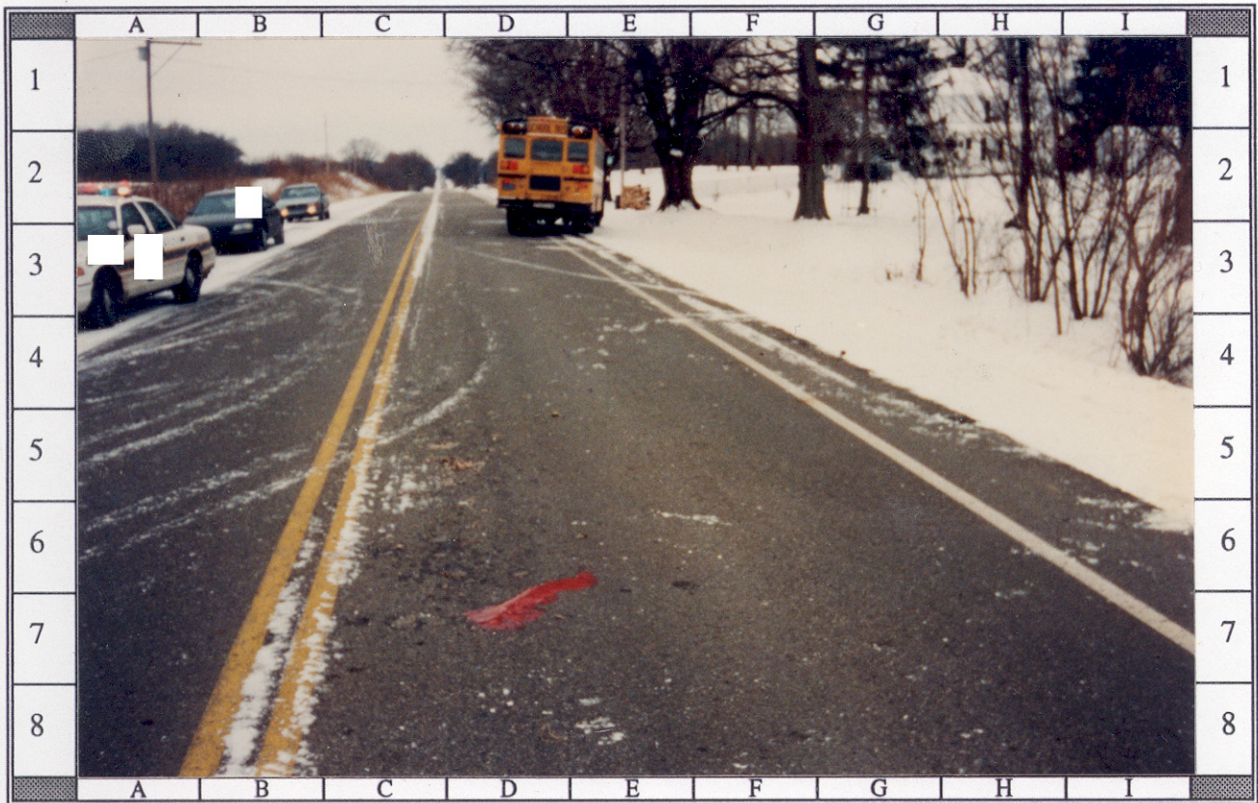
01: On-scene view in westbound lane of residual impact evidence of child who had just exited bus; NOTE: possible brain tissue on pavement (cells C5--D5)

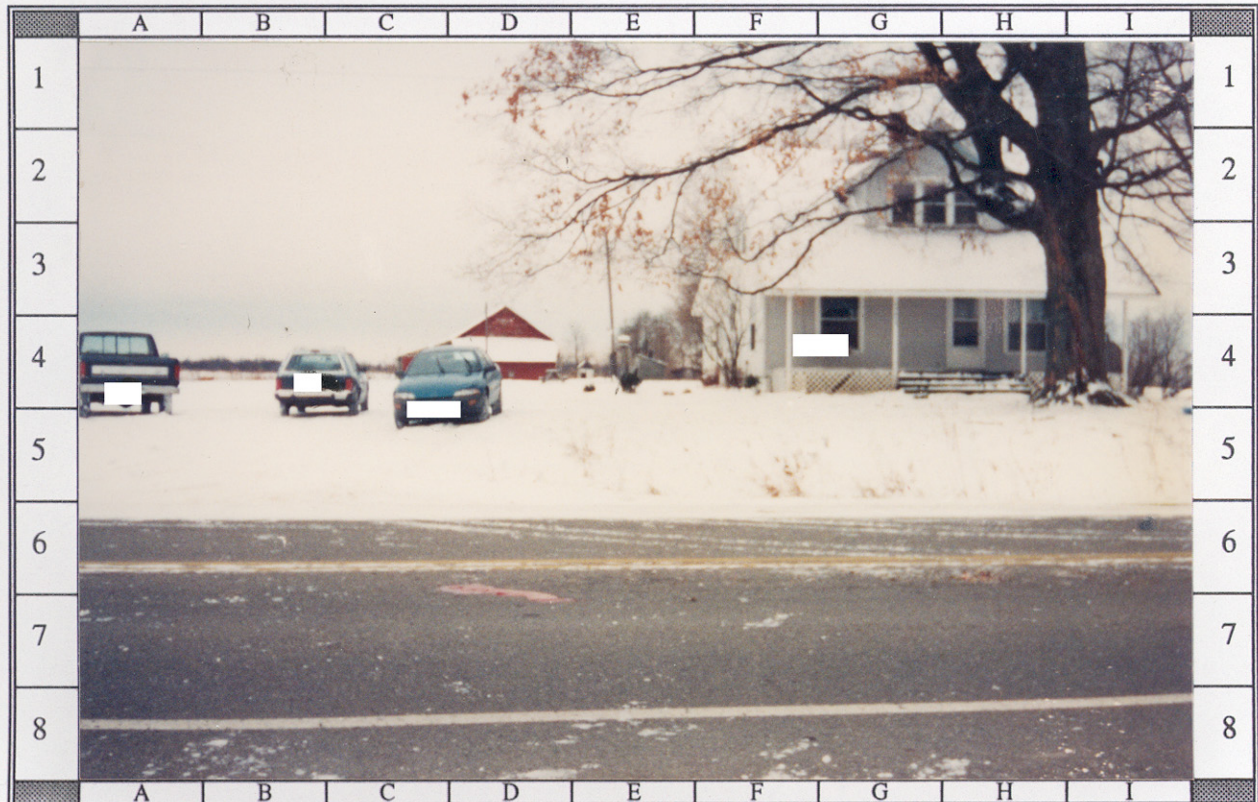
02: On-scene southward view in westbound lane of residual impact evidence of child who had just exited bus; NOTE: child heading toward driveway in background

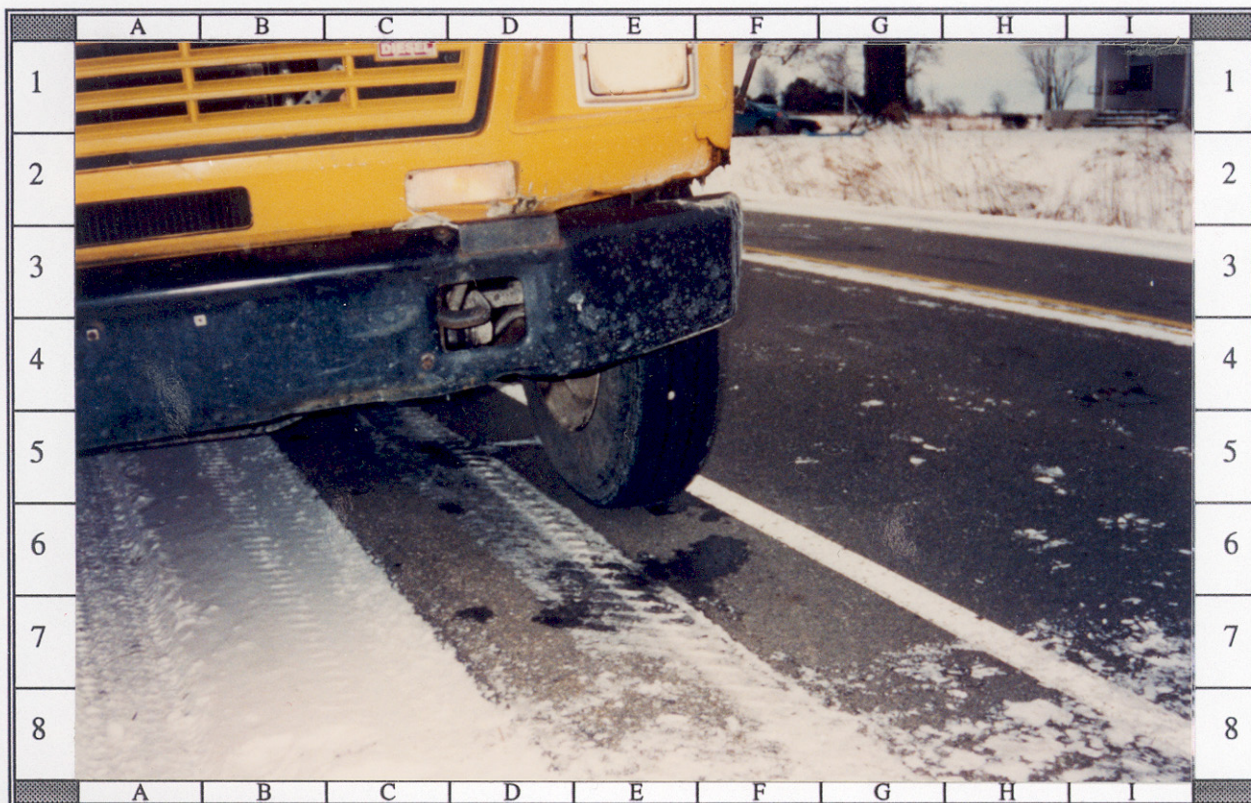
03: On-scene view of Case Vehicle's front left bumper and left front tire, which knocked child down and passed over her, respectively

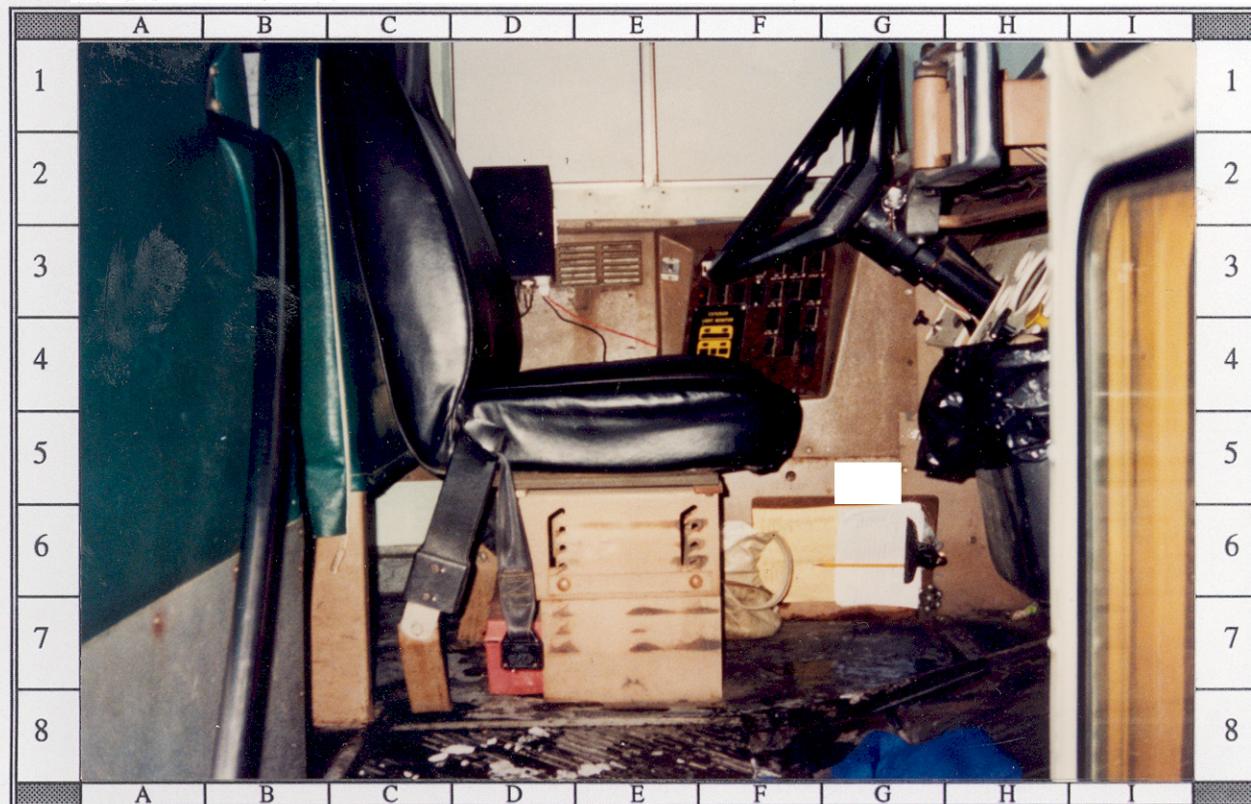
04: On-scene view of Case Vehicle's driver seating area, showing two-point lap belt and driver's seat--positioned fully rearward

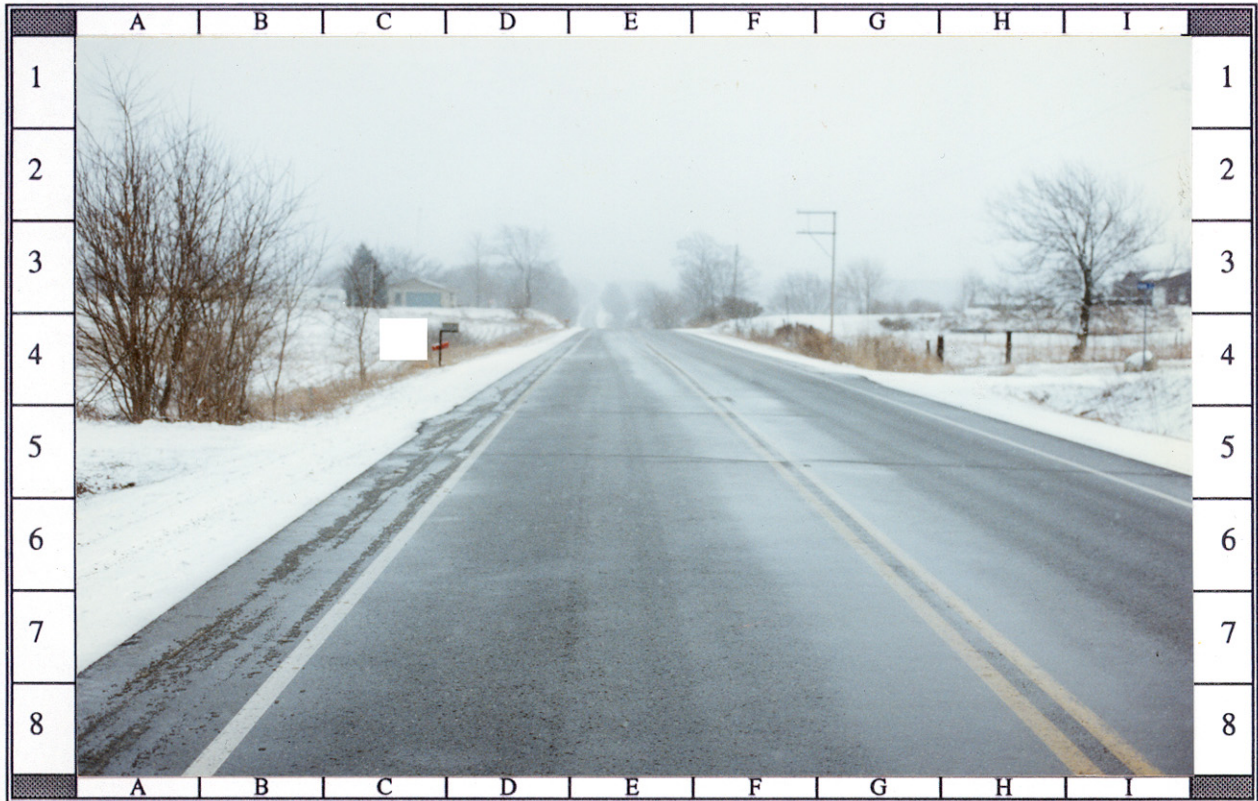
05: Eastward view of approximate impact location of westbound Case Vehicle and child who had just exited bus; NOTE: impact near mailbox (cell E4)

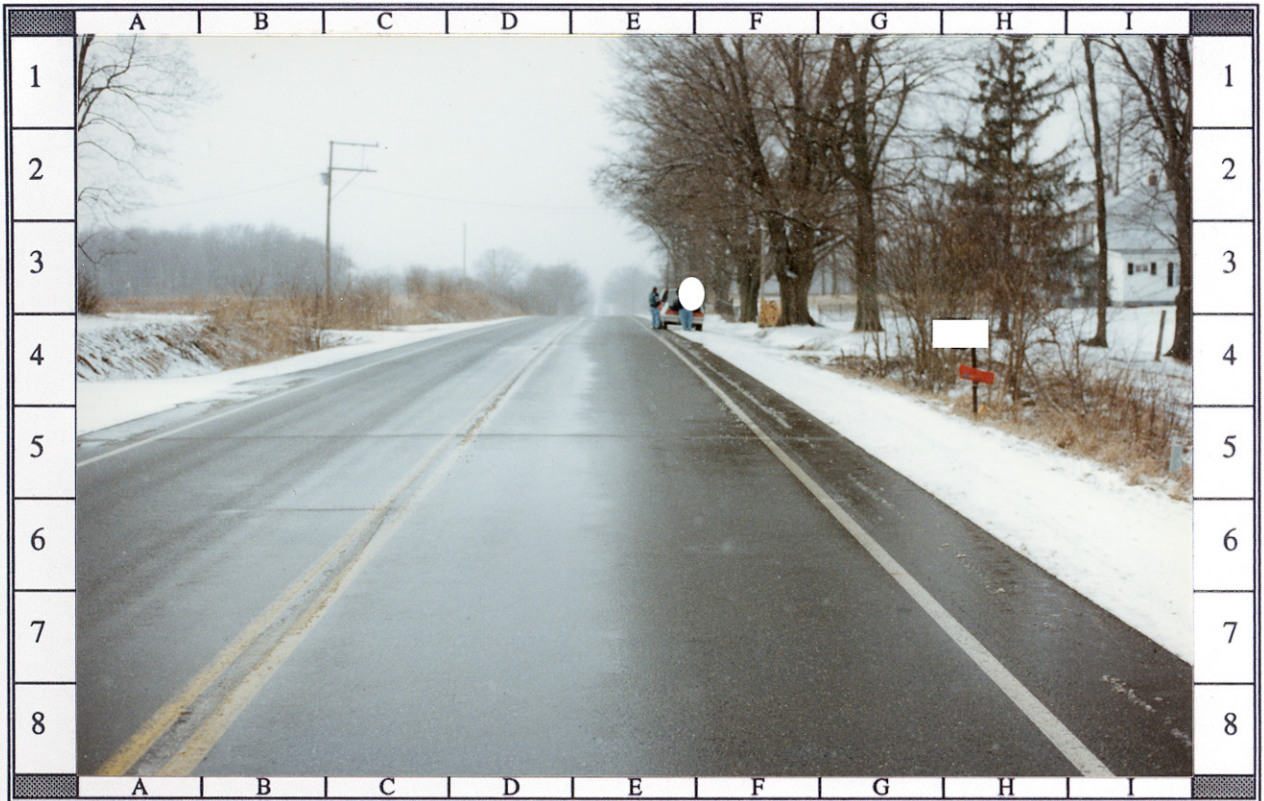
06: Case Vehicle's westward travel path in westbound lane approximately 50 meters (164 feet) east of impact near mail box (cell E4)

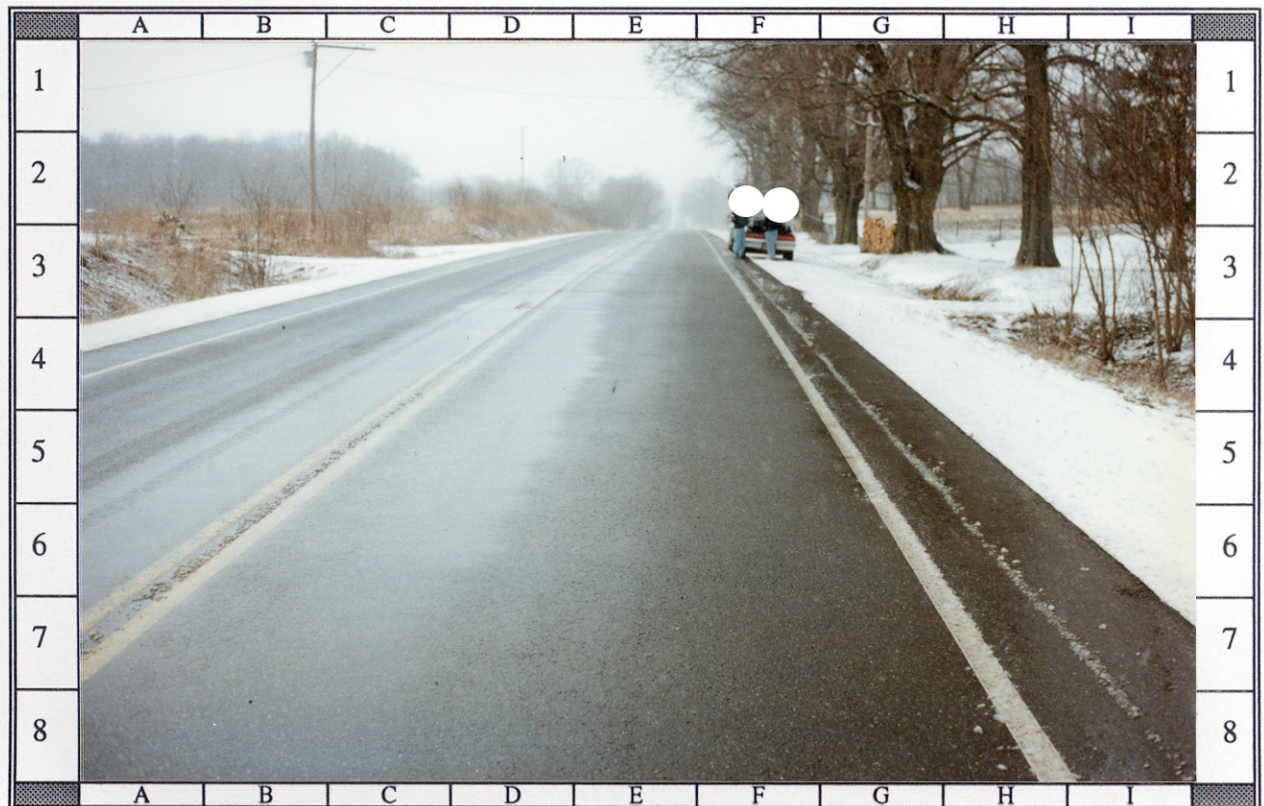
07: Case Vehicle's westward travel path in westbound lane approximately 25 meters (82 feet) east of impact near mail box (cell D4)

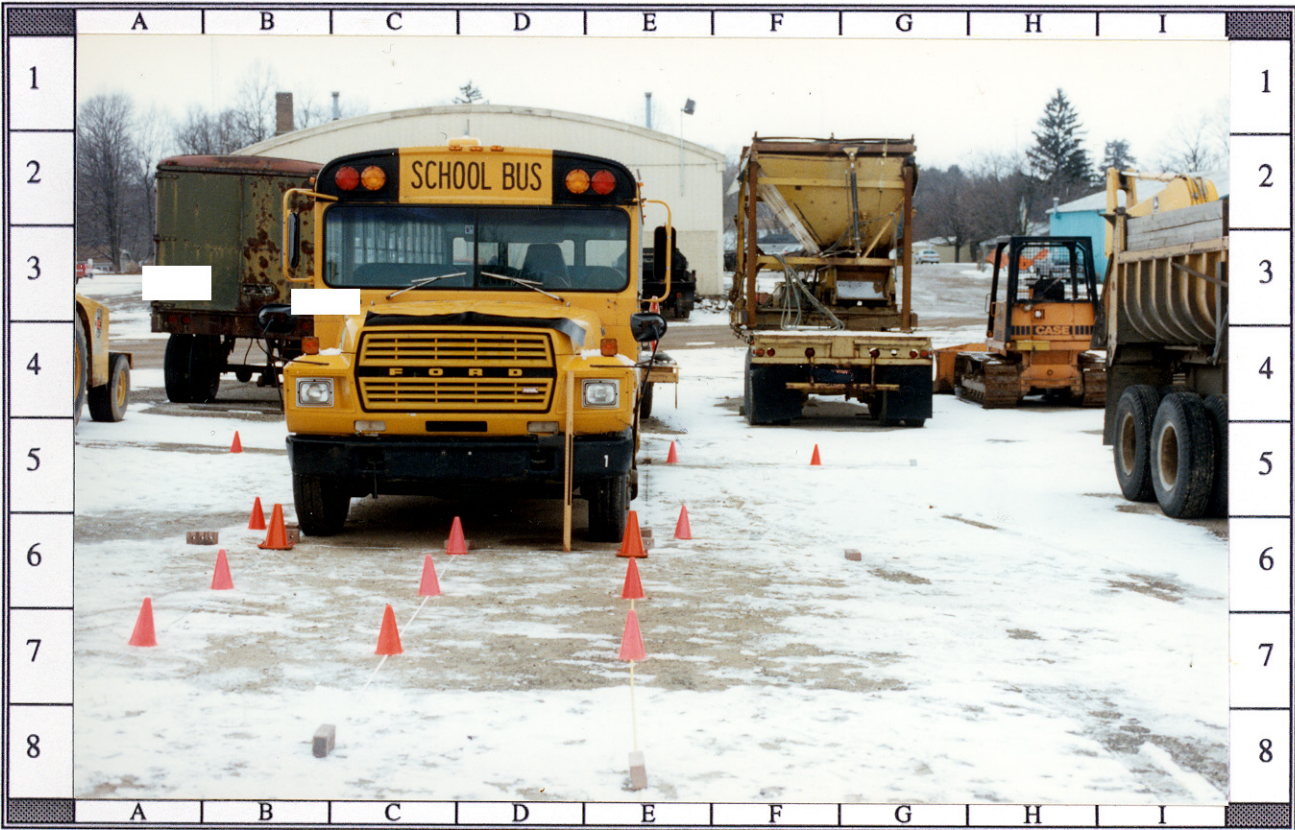
09: Case Vehicle viewed in alignment with cones A, D, and G and longitudinal vertical plane tangent to left bumper; NOTE: measuring stick marks impact area

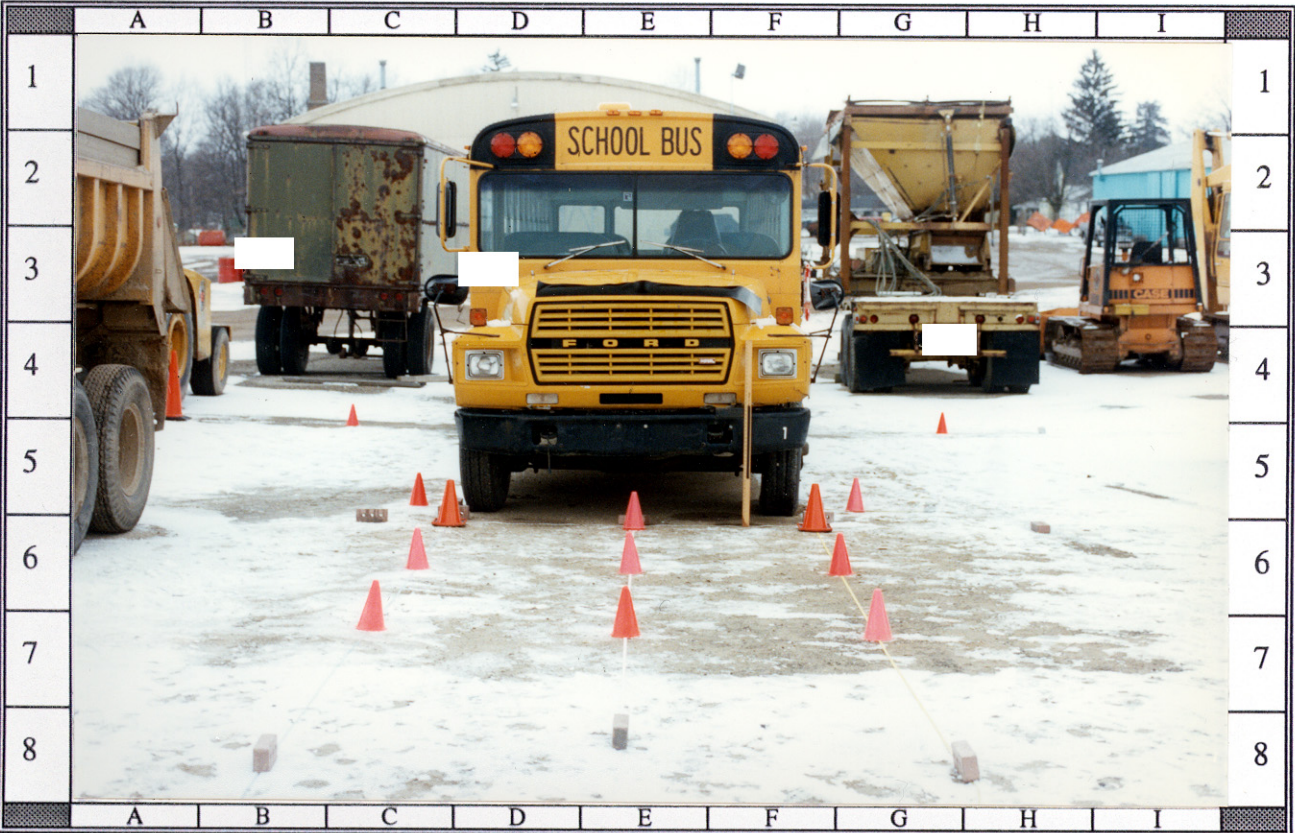
10: Case Vehicle viewed in alignment with cones B, E, and H and longitudinal vertical plane through center of bus; NOTE: measuring stick marks impact area

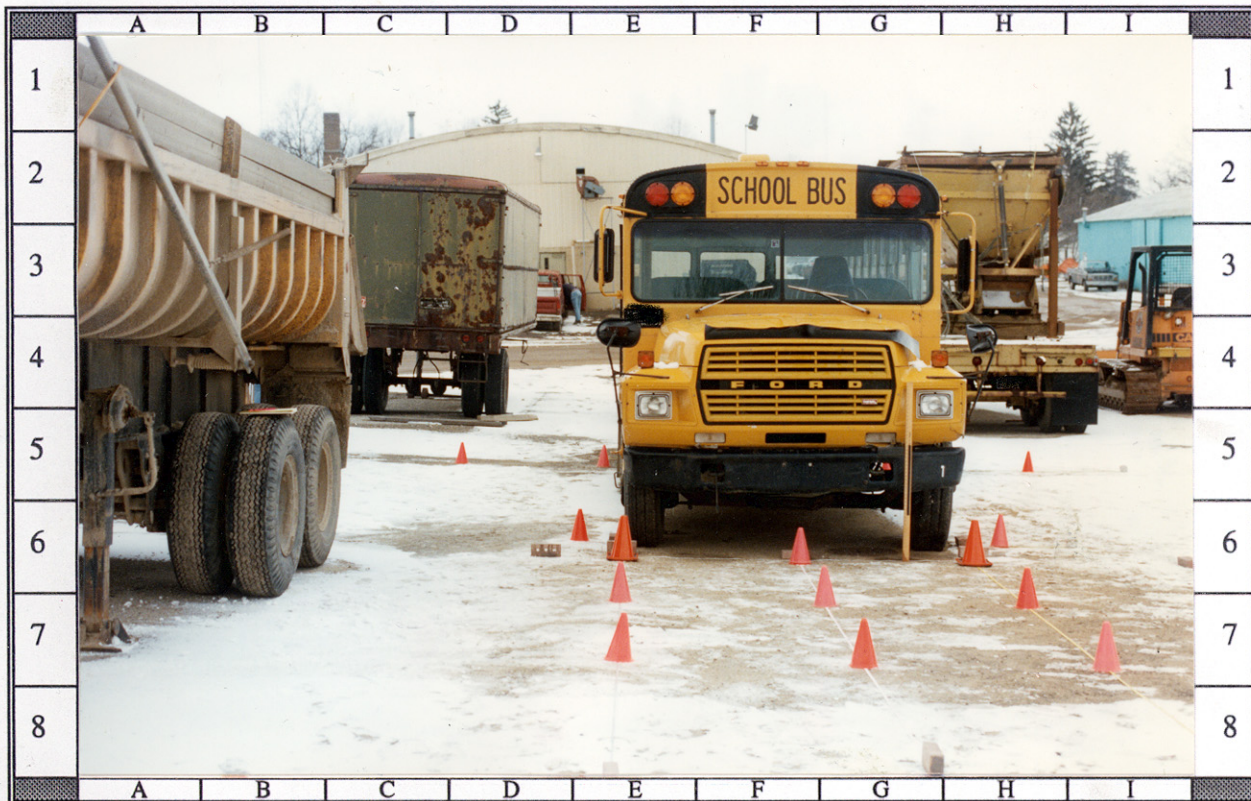
11: Case Vehicle viewed in alignment with cones C, F, and I and longitudinal vertical plane tangent to right bumper; NOTE: bricks secure tape measures

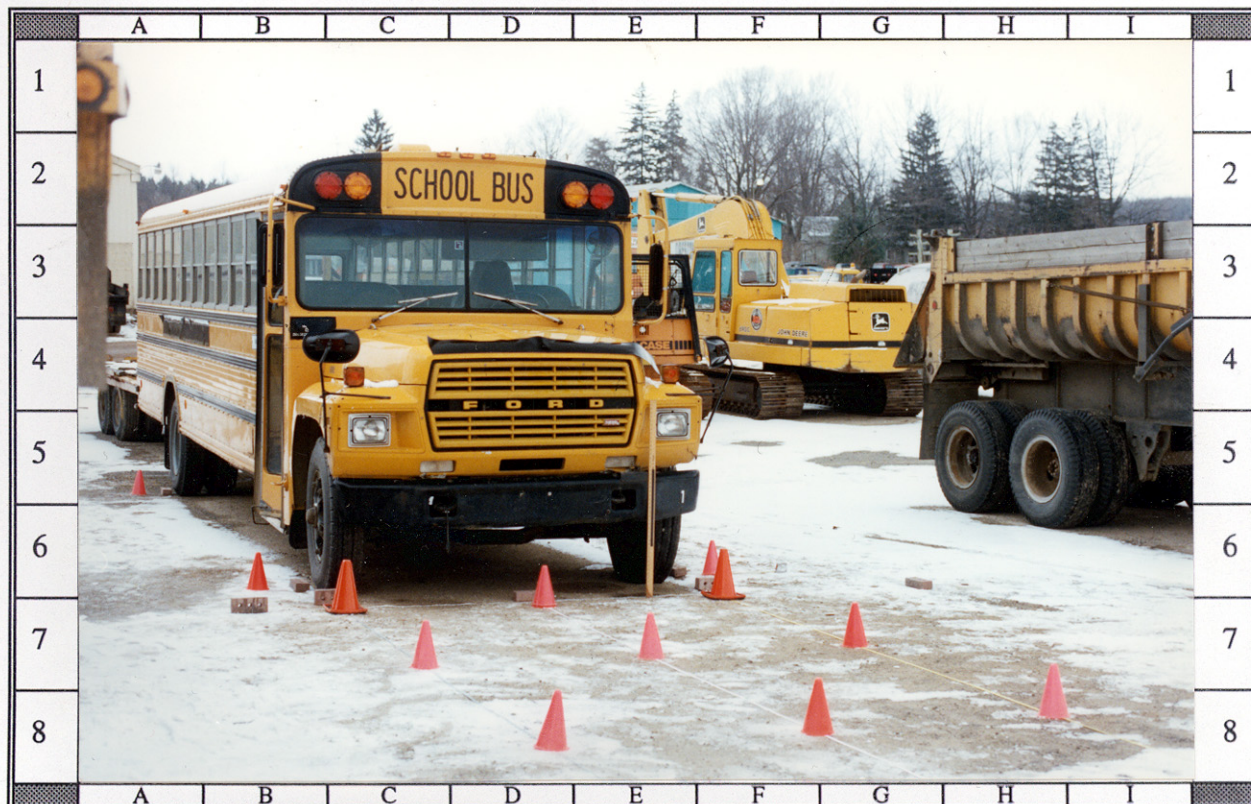
12: Case Vehicle and forward test cones A-I viewed from approximately 30 degrees right of front; NOTE: outside, convex, rearview mirrors mounted bilaterally

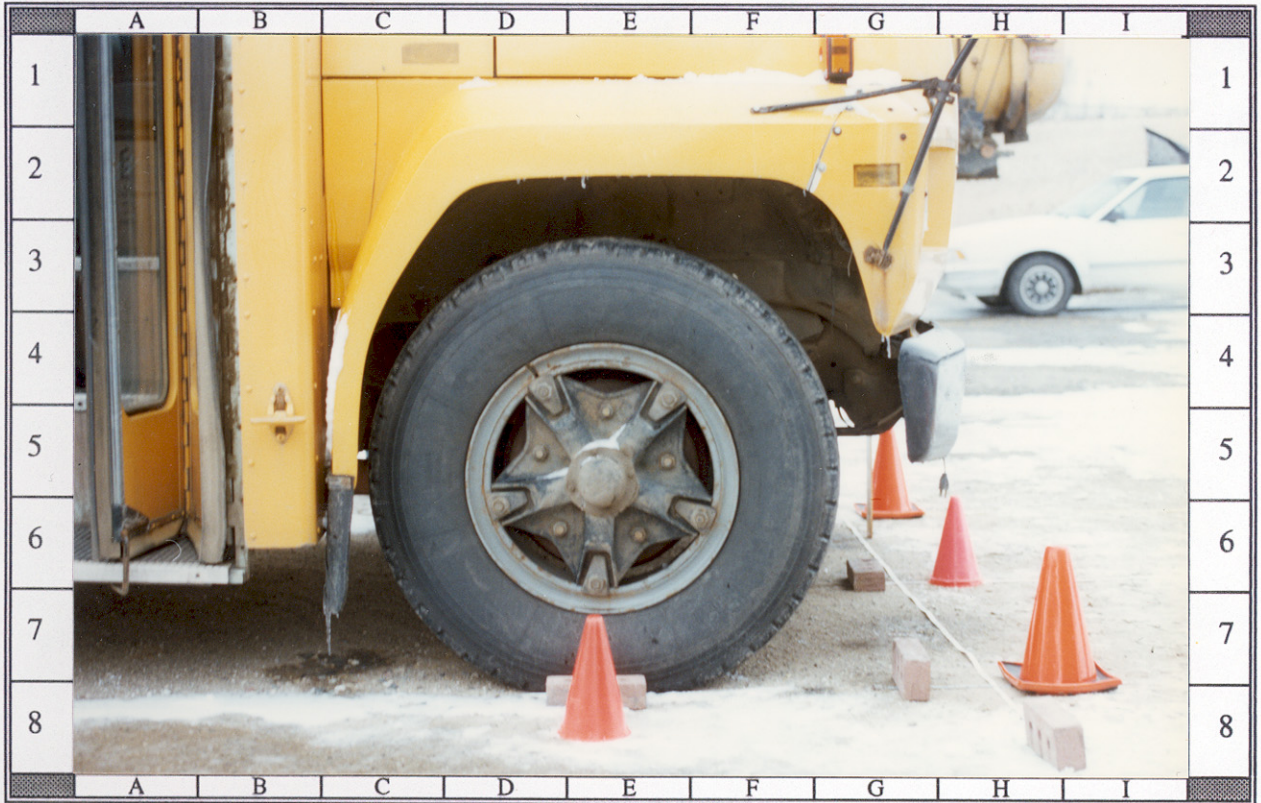
13: Case Vehicle's right front wheel and test cone K aligned with axle; NOTE: bracket locations for single right, outside, convex, rearview mirror

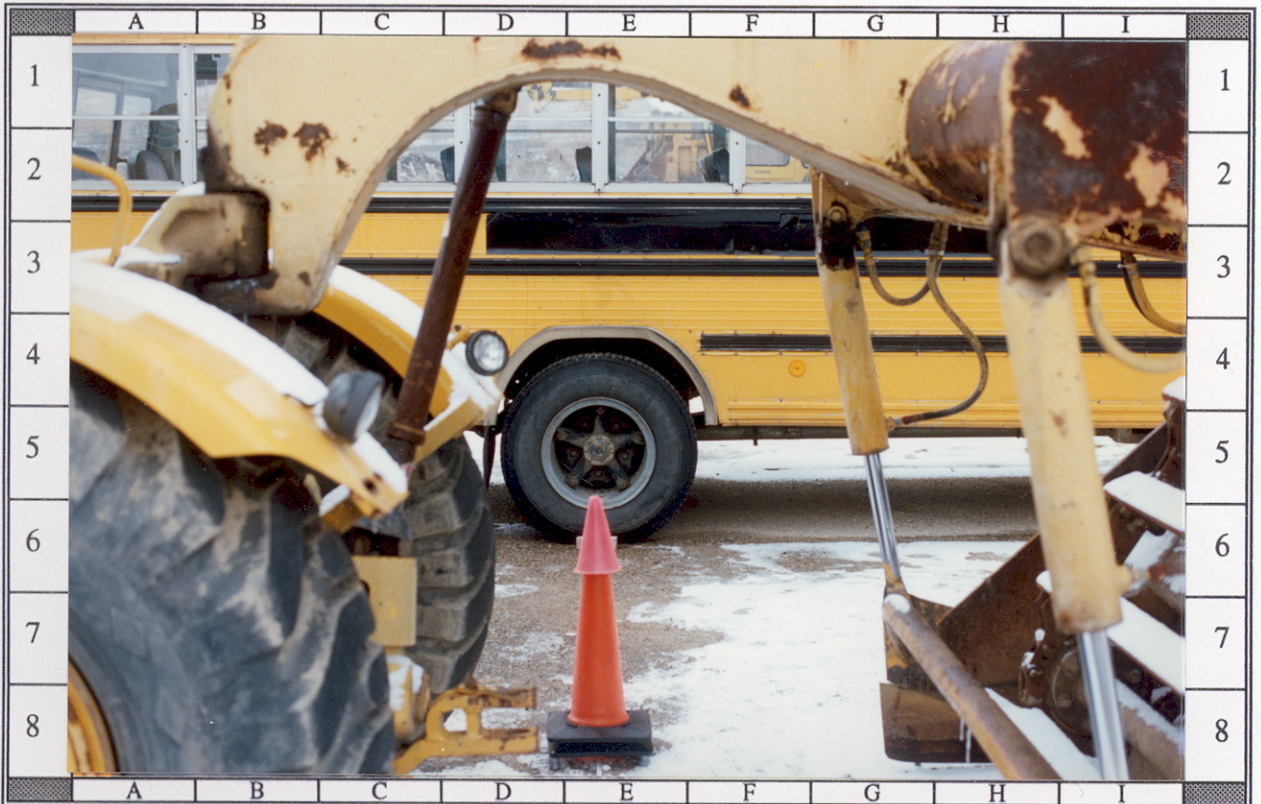
14: Case Vehicle's right rear, dual wheels and test cone P aligned with axle; NOTE: test cone P blocks view of cones O and N

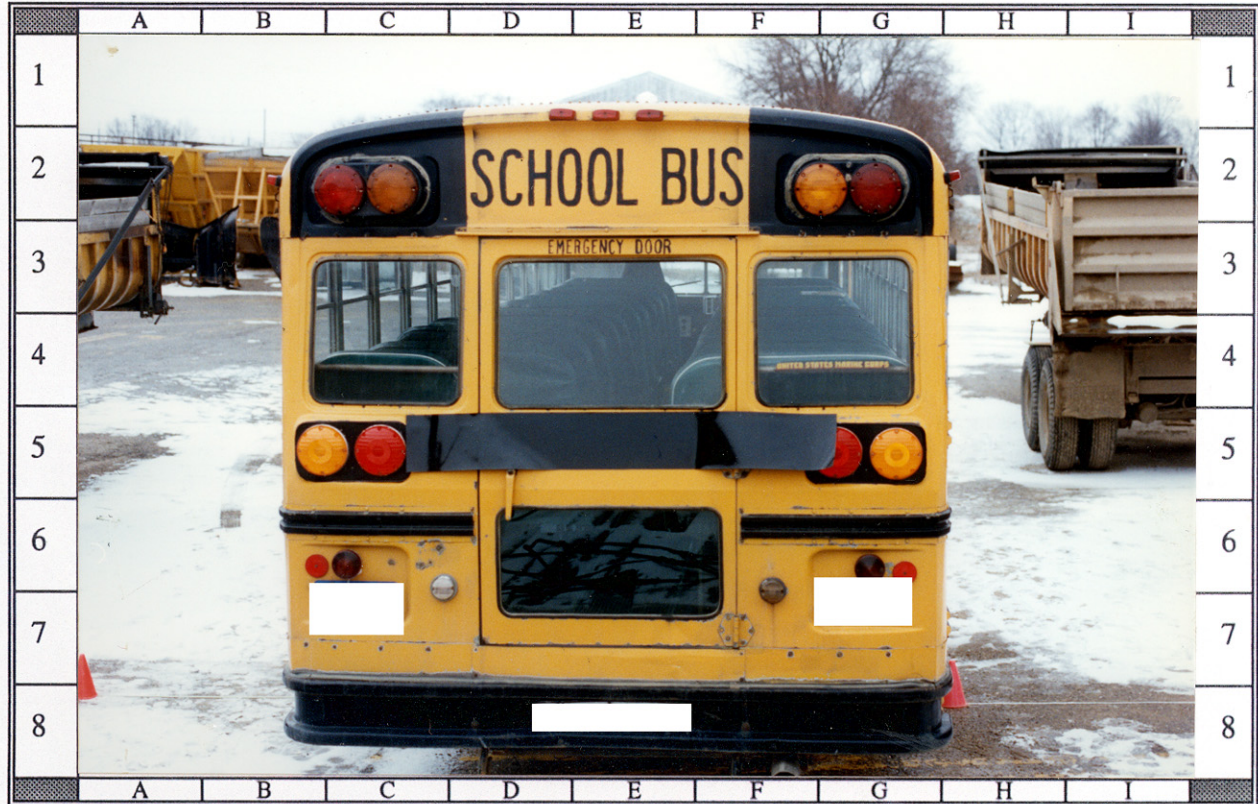
15: Case Vehicle and test cones B, C, F, I, K, N, and O viewed from approximately 45 degrees right of back; NOTE: cones N and O are aligned with rear axle

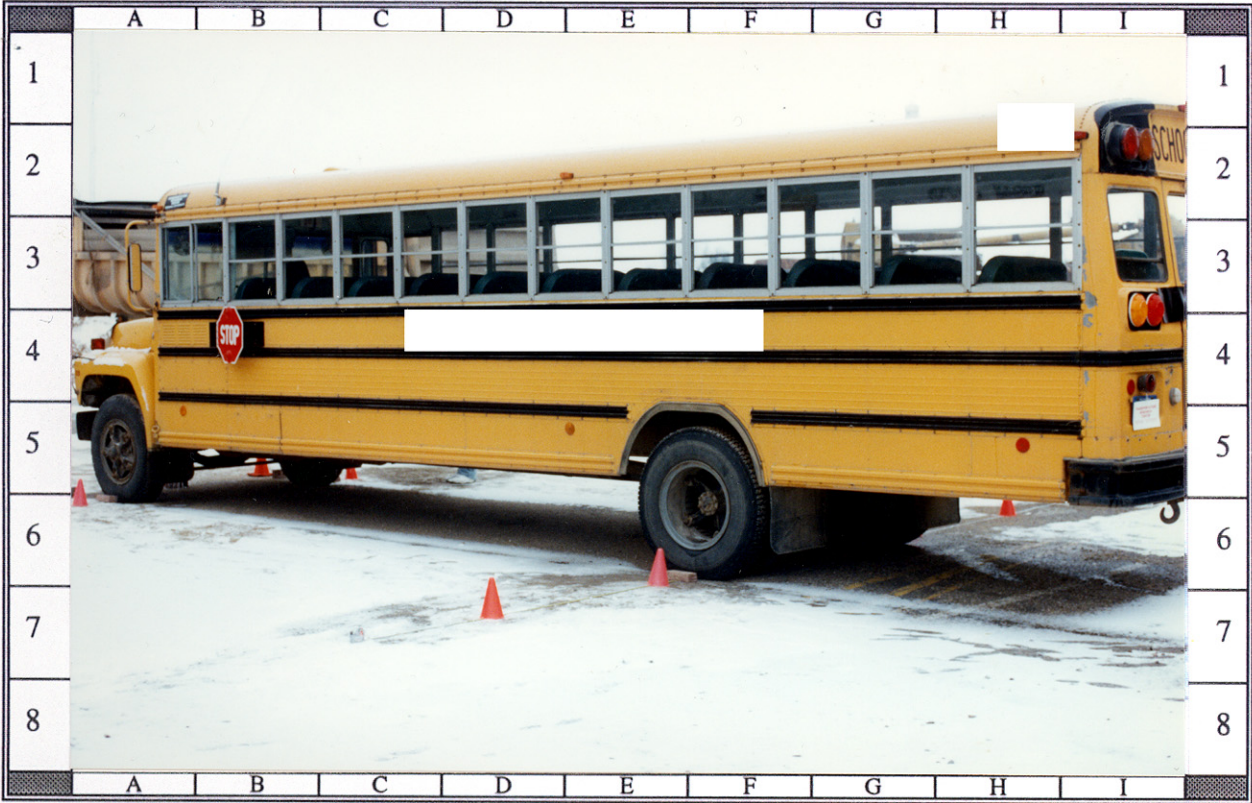
16: Case Vehicle's back and partially visible test cones L (left) and N (right); NOTE: seating visible through glazing

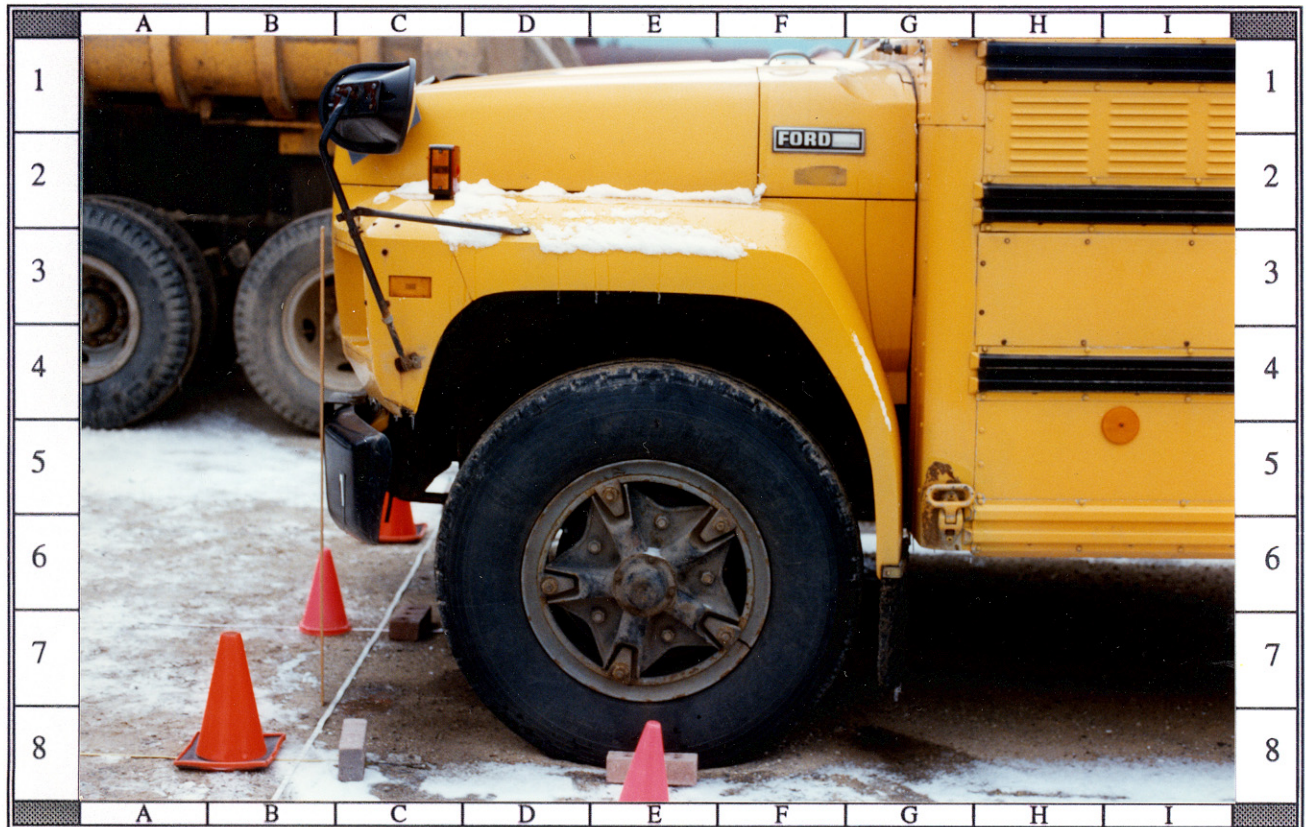
19: Case Vehicle's left front wheel and test cone J aligned with axle; NOTE: bracket locations for single left, outside, convex, rearview mirror

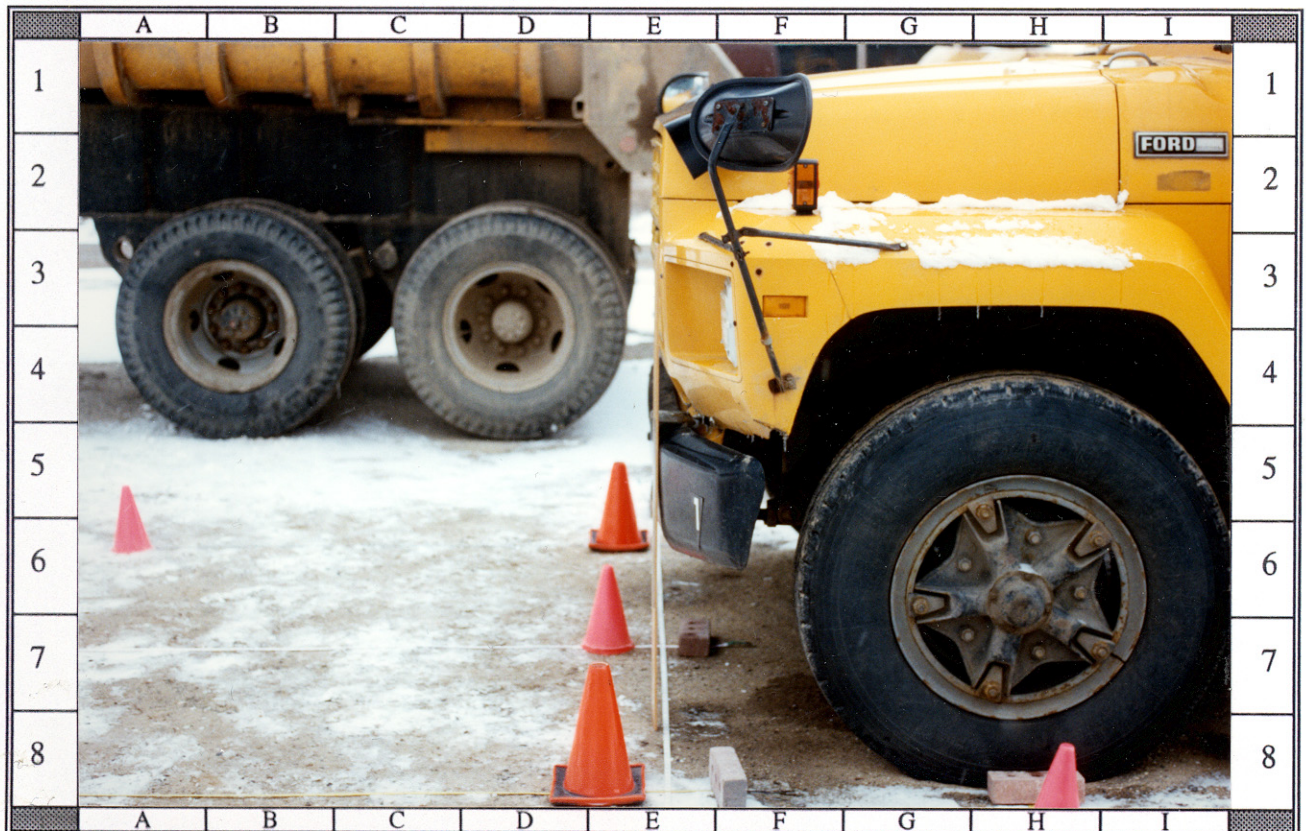
20: Case Vehicle viewed in alignment with cones G, H, and I and transverse vertical plane tangent to front bumper; NOTE: right side mirror forward of one on left

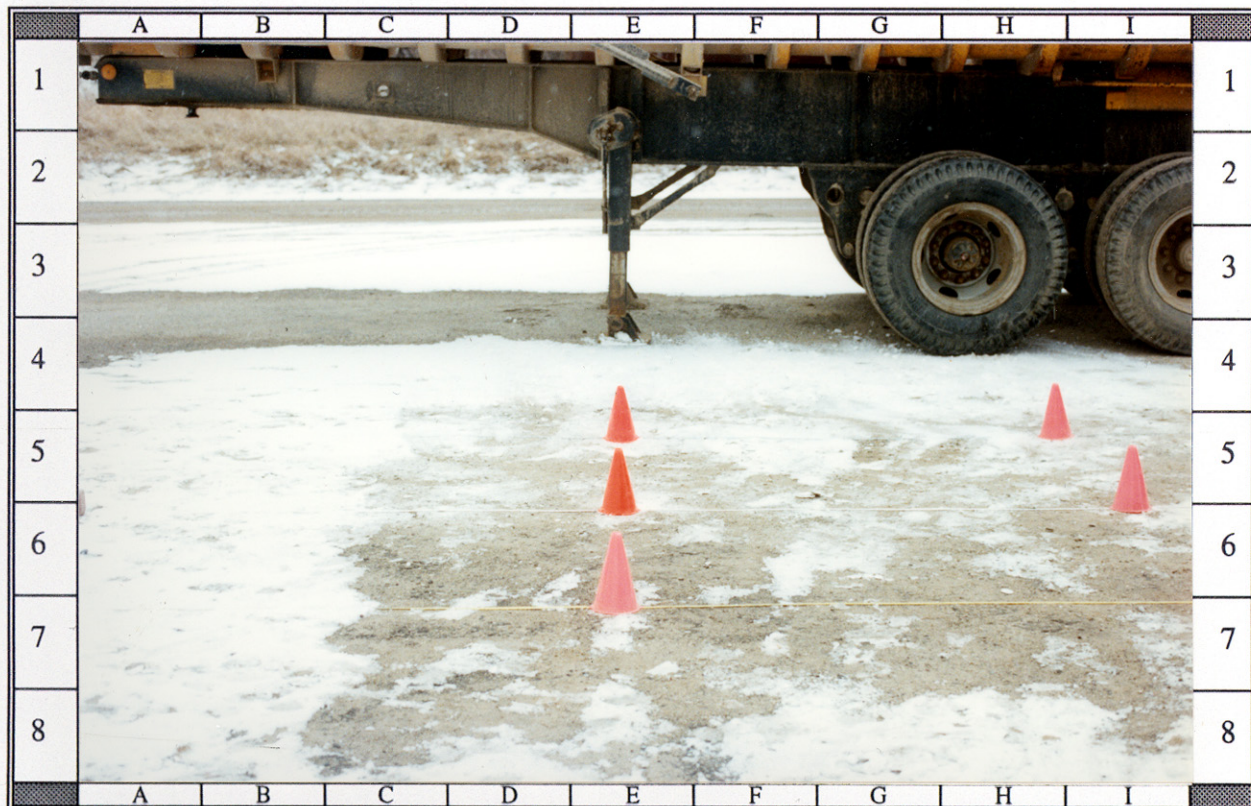
21: Case Vehicle's forward test cones D, E, and F viewed in alignment with transverse vertical plane 1.83 meters (6 feet) forward of front bumper

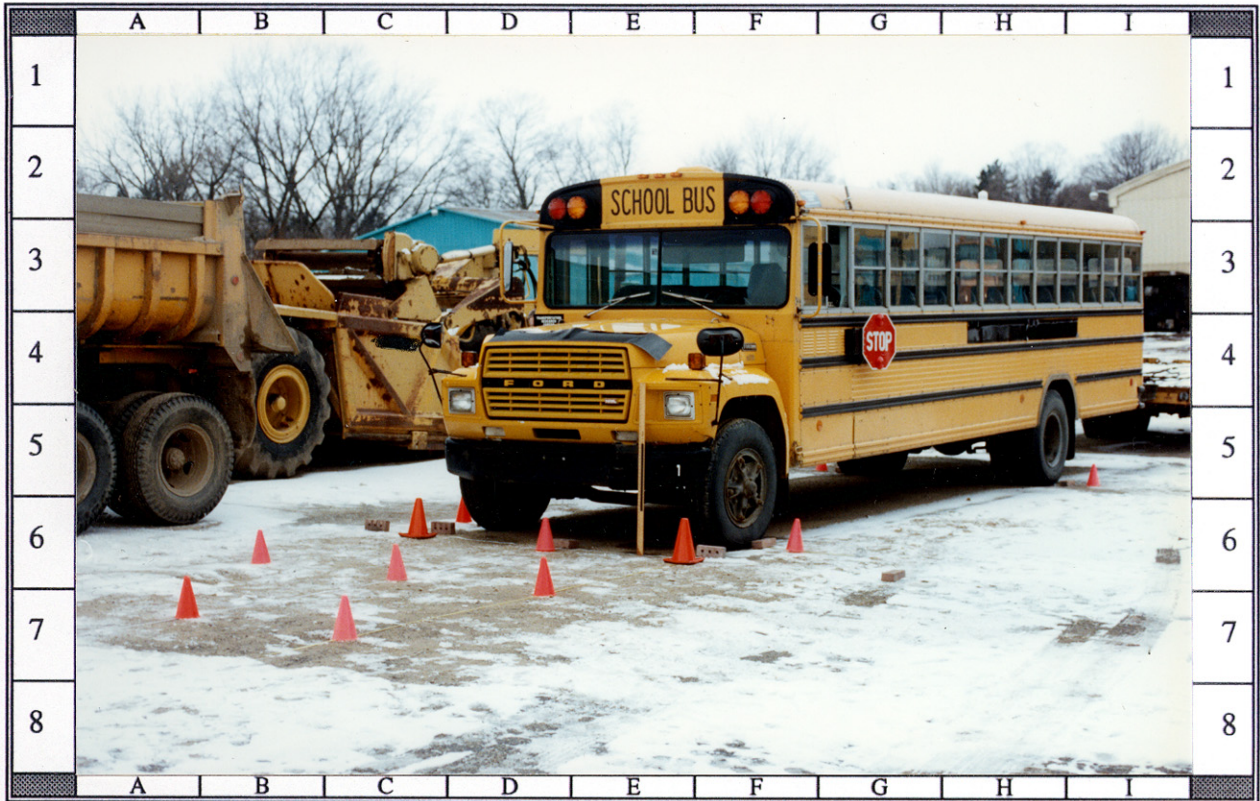
22: Case Vehicle's forward test cones A, B, and C viewed in alignment with transverse vertical plane 3.66 meters (12 feet) forward of front bumper

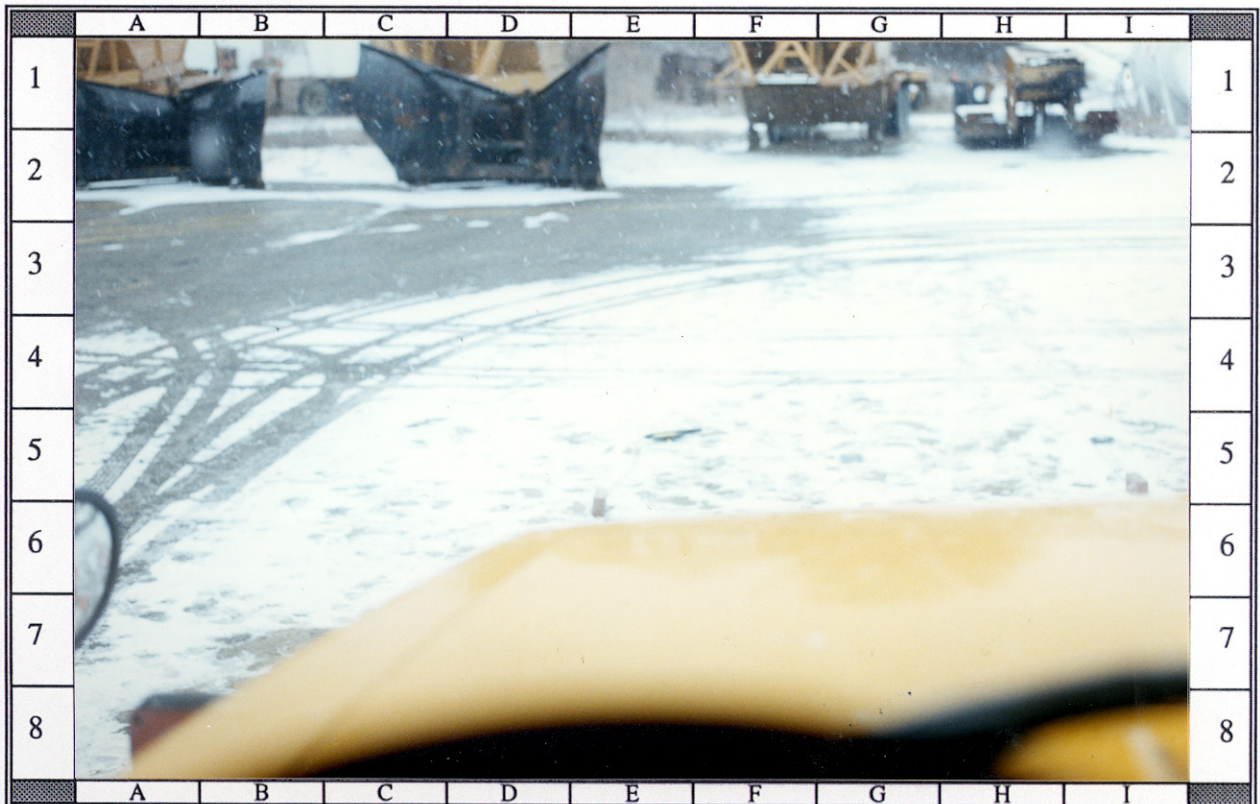
24: Case Vehicle driver's forward view through windshield of left third of bus's front; NOTE: bricks (cells E5 and I5) are ~ 6.1 m (20 ft) forward of bumper

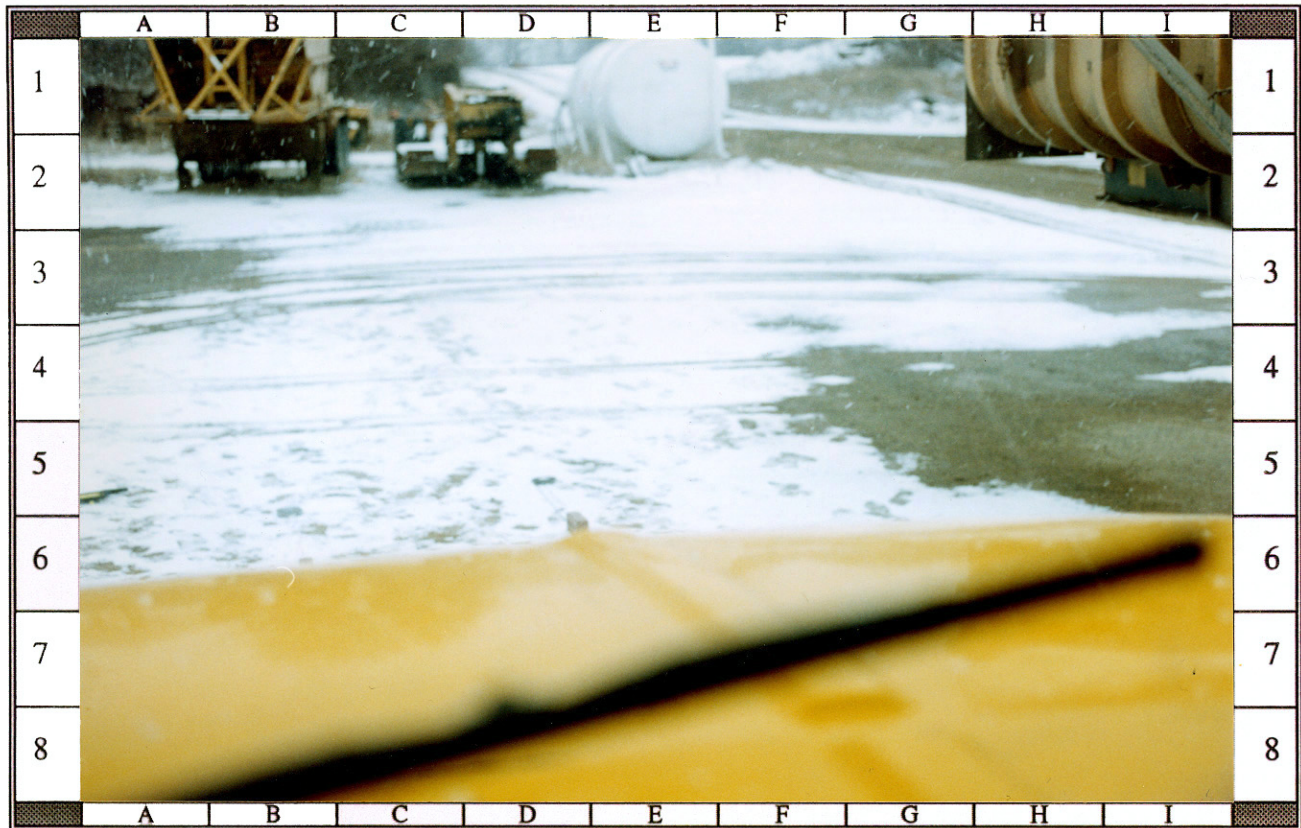
25: Case Vehicle driver's forward view through windshield of center third of bus's front; NOTE: brick (cell D6) is ~ 6.1 meters (20 feet) forward of bumper
